Manhole Inspection Summary

Manhole # S29AA_112MH

Record Plat: **29AA** Node: **112** Status: **New Manhole (Not in GIS)** Insp Date: **12/11/07 10:27 AM**

Location Address: **REAR OF 1015 ARGYLE AVE**

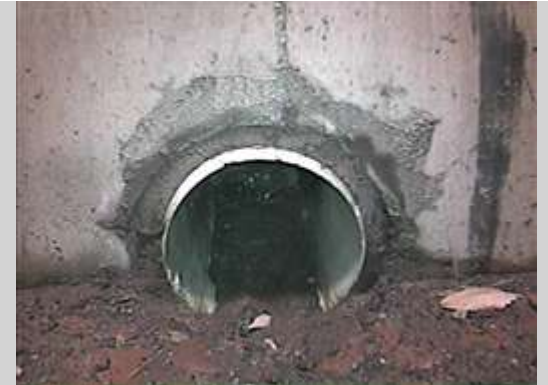
12 O'Clock Outflow

8 in. Circular Gravity Sewer
Pipe Out @ 12 O'Clock

Infiltration: **None** Pipe Seal Cond: **Sound**
